The Runnins River Report - 2011

Seekonk High School, Seekonk, Massachusetts (2012). *The Runnins River Report - 2011*. In Watershed Access Lab Projects. Project 120.

Runnins River Project 2011

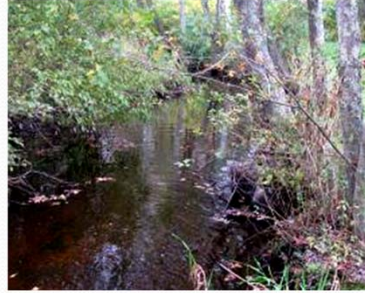
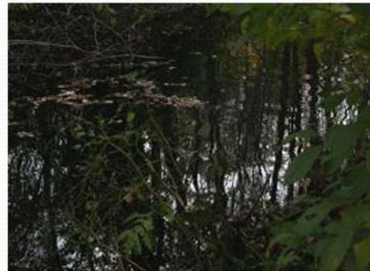
Pamden Lane, Upstream Site

- The residents yard starts a few feet away from the river, after a few feet of brushy edge.
- There are many different species of plants surrounding the site.
- There are rocks around the edges in the shallowest part of the river and the bottom turns sandy at the deepest part.

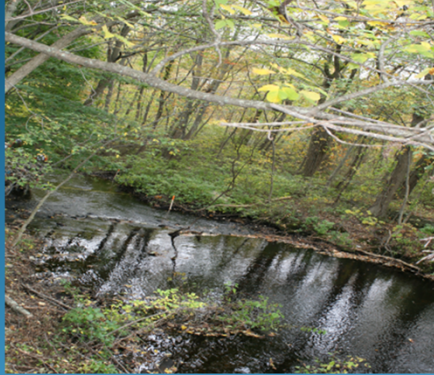
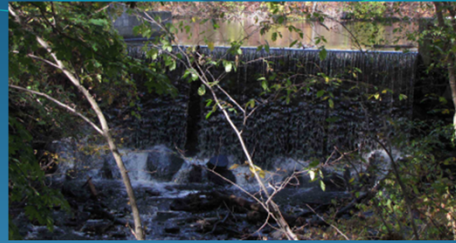
Burr's Pond

- A large amount of bugs living in/on the water, such as Trichoptera in the water and mosquitoes or flies outside the water.

- Many trees, plants, and rocks occupy the area in and around the river.

- Waterfall increases the turbidity of the water and increases the O₂ level.

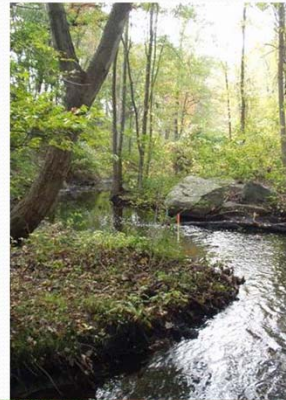
- Physically grabbed and tested water samples.
- Filtered the water samples on sight and sent them to BWSU.
- Determined phosphate levels and nitrate levels of river.
- Tested turbidity using a Secchi disk tool.
- Read the temperature, pH, and dissolved oxygen of water.

Turbidity-how far underwater can you see/visibility.

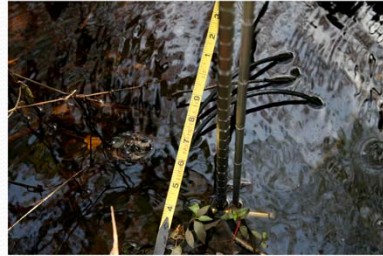
- Our group used a device called US Geological Society depth and Marsh McBirney flow meter to measure the flow depth in each section of the river.
- We measured depth and flow every 1-2 feet across the river.
- We calculated the average area and flow, and calculated the discharge for each site.

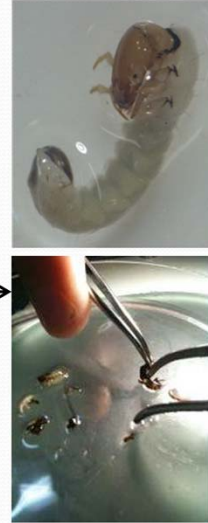
Trichoptera

- We first started by separating the different species under the microscope as shown here: _____
- The top three groups of macros collected were Ephemeroptera, Pelecypoda, and Trichoptera. Most were Pelecypoda.
- After our Lab we all put our amounts together to get a class totals for the various species.

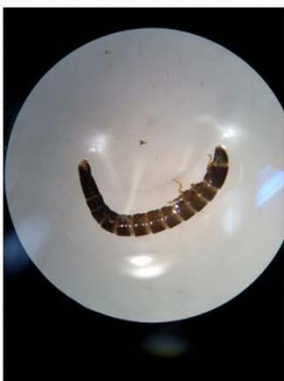
Pictures of Macros-Upstream

<p>(Scuds) 9.6% Amphipoda Tolerance Value: 7</p>

<p>(Mayflies) 19.2% Ephemeroptera Tolerance Value: 2</p> <p>(Caddisflies) 14.4% Trichoptera Tolerance Value: 3</p> <p>(Riffle Beetles) 10.1% Coleoptera Tolerance Value: 4</p>

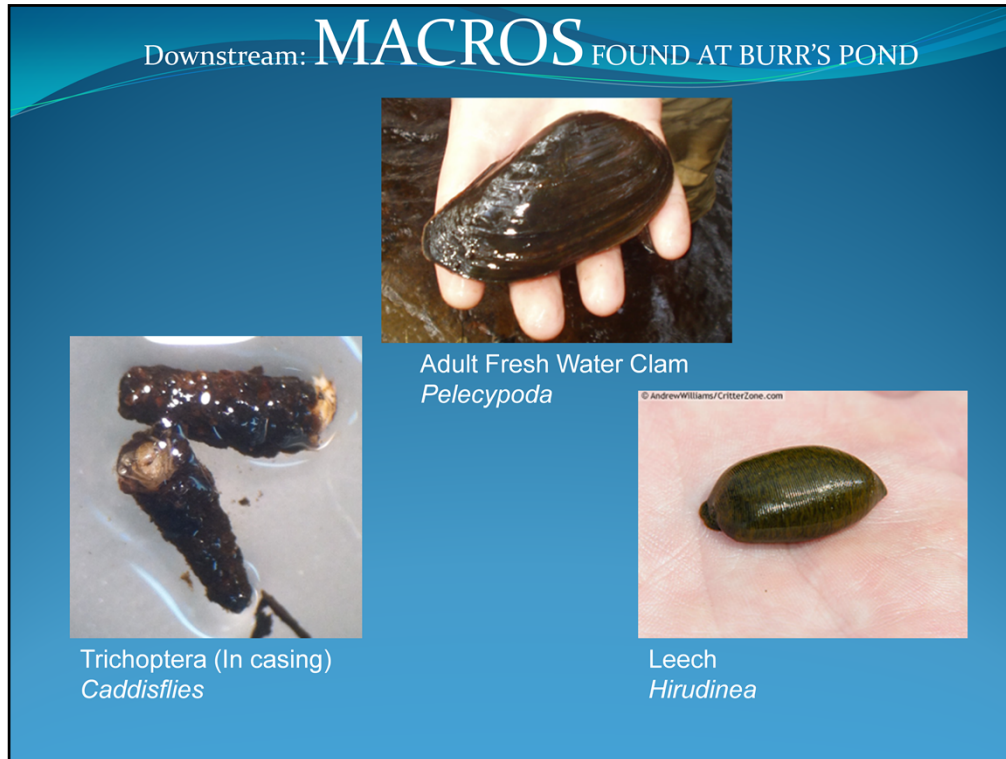
Geena 17

Picture to the bottom left is a picture of trichoptera in its case. This case is made up of little rocks. Out of all the bugs we found, the trichoptera make up 10%.

Picture at the top is a picture of pelecypoda (fresh water clam). We found over 8k of these most of them are juvenile but this one is an adult. These made up 10% of all the bugs.

Picture to the bottom right is a leech. Out of all the bugs we found, leeches made up 10% of the bugs.

Pollution tolerance of three that's means that it can live in polluted water but would rather not.

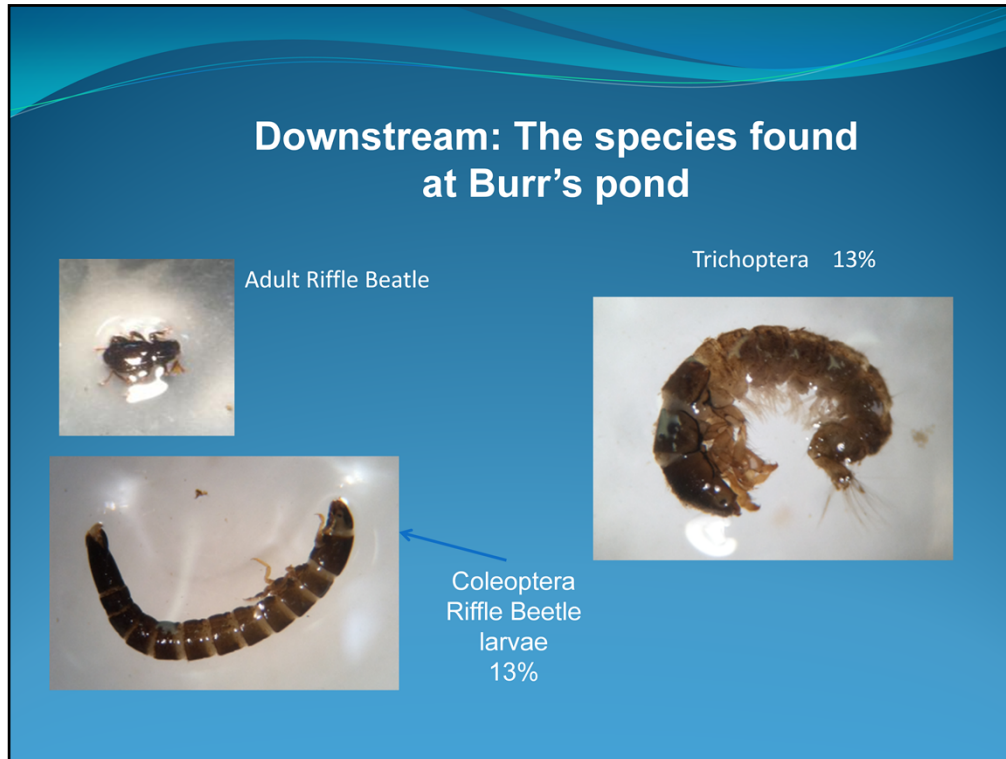
Lamoureux 18

-The picture to the left is an adult riffle beetle. It looks nothing like the young riffle beetle. The bottom picture is a prime example of that statement.
